Water vapor transfer network model building up screen

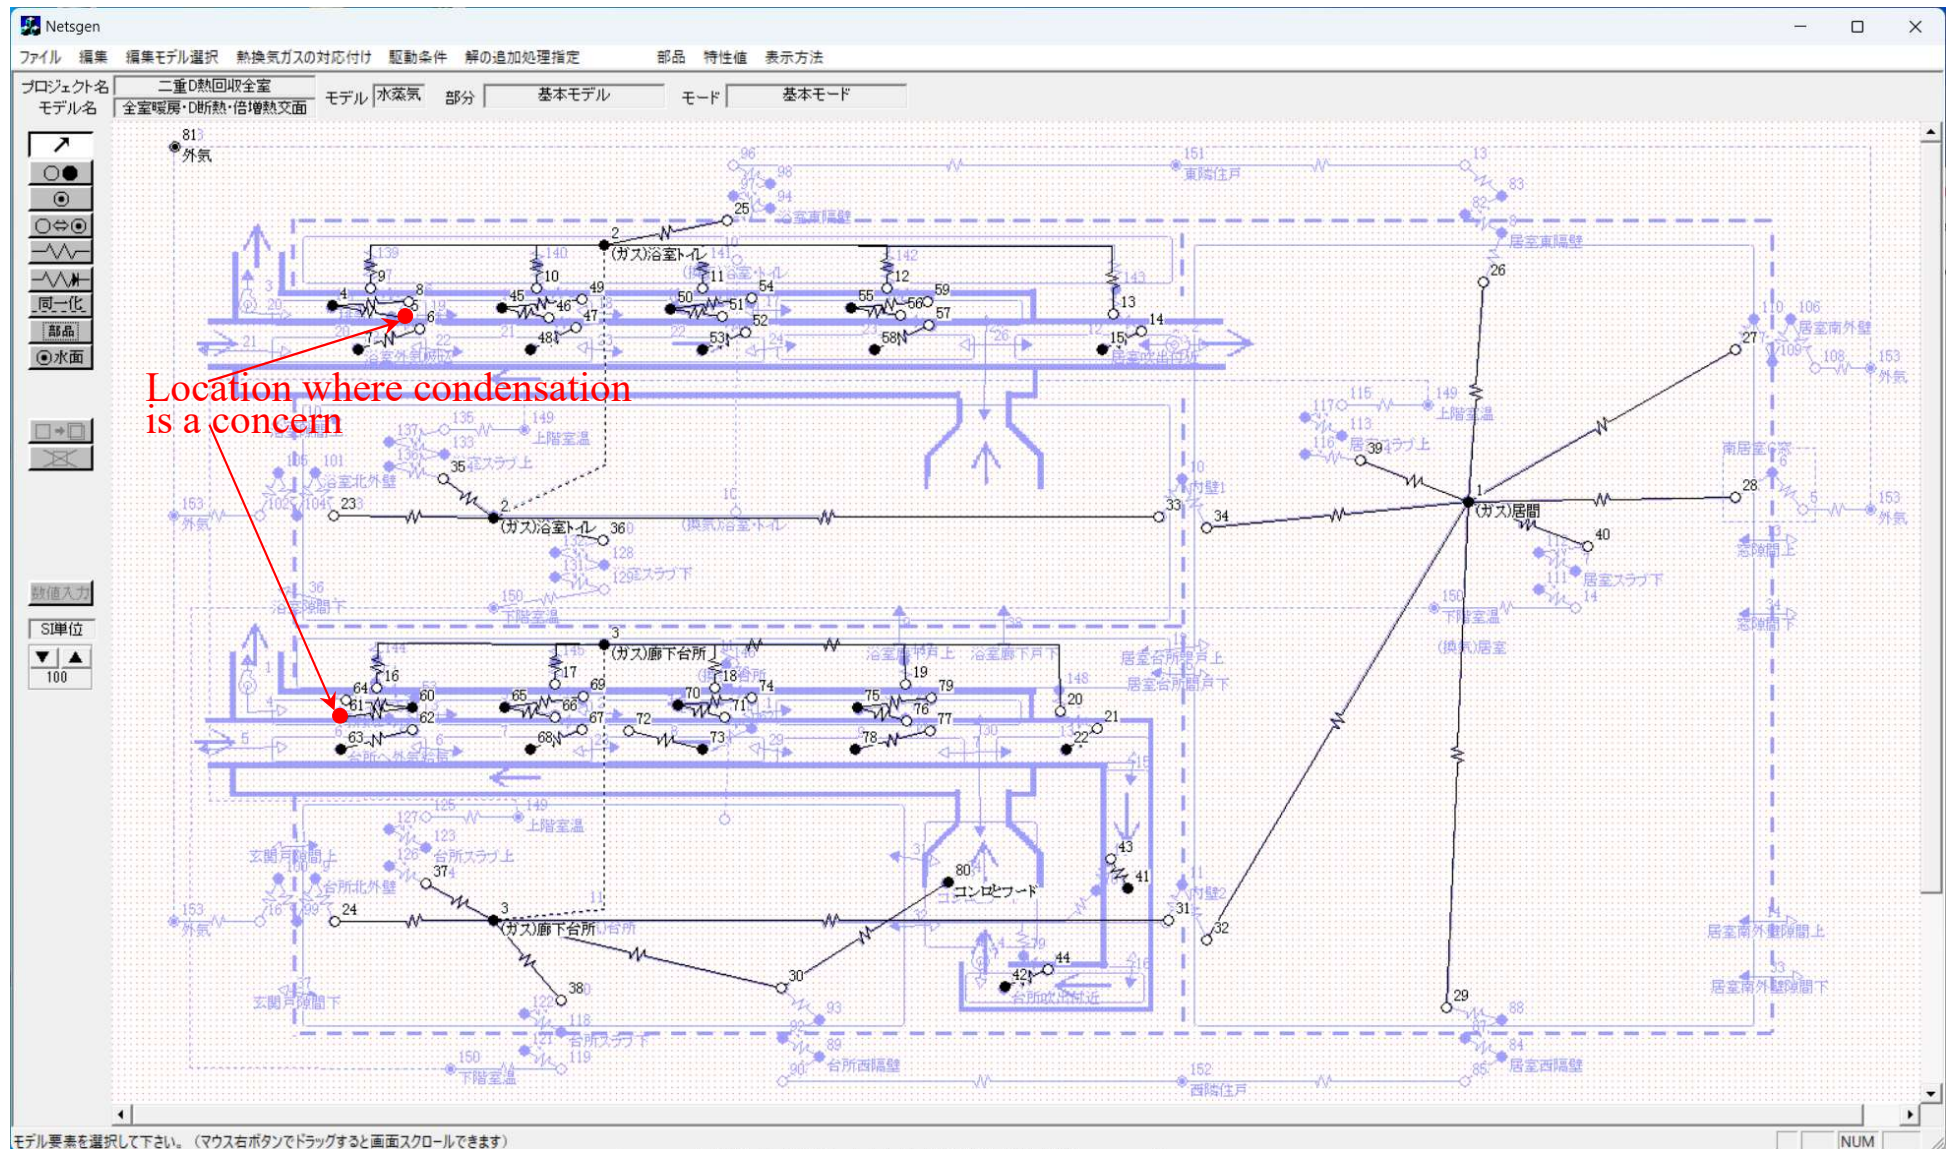
- Water vapor does not pass through the steel plate. The two nodes on the inner and outer surfaces of the spiral duct is not connected.
- Moisture vapor movement was assumed to be mainly caused by air movement, and moisture conduction through walls, etc. was omitted.
- Water vapor is generated constantly in the bathroom, and intermittent in the bedroom and in the kitchen.
